**HYUNDAI**NEW THINKING.
NEW POSSIBILITIES.**Technical Service Bulletin**

GROUP	NUMBER
CAMPAIGN	11-01-022
DATE	MODEL
JUNE, 2011	SONATA HYBRID (YF HEV)

SUBJECT NVLD INSPECTION/REPLACEMENT AND ECM UPDATE
(SERVICE CAMPAIGN TF9)

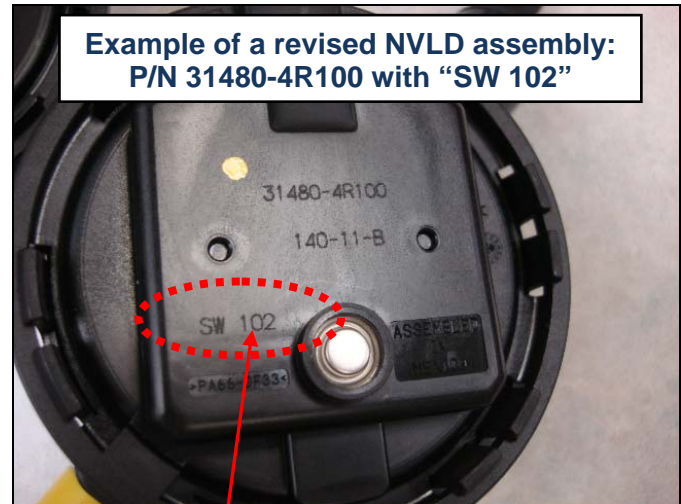
- NVLD assemblies with “**SW 102**” are revised parts. **DO NOT REPLACE.**
Possible Part Numbers:
 - **31480-4R000**
 - **31480-4R100**
- NVLD assemblies with “**SW 103**” are old version parts and **must be replaced.**
Possible Part Numbers:
 - **31480-4R000**

**Example of a revised NVLD assembly:
P/N 31480-4R100 with “SW 102”**

Regardless of the part number, NVLD assemblies with “SW 102” stampings are revised parts that should be reinstalled. **DO NOT REPLACE.**

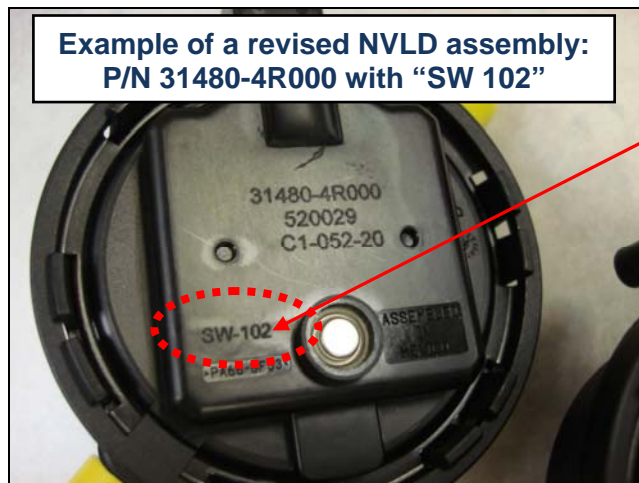
**Example of a revised NVLD assembly:
P/N 31480-4R000 with “SW 102”**

**SW 102 = REVISED
SW 103 = REPLACE**
