**HYUNDAI**NEW THINKING.
NEW POSSIBILITIES.**Technical Service Bulletin**

GROUP	NUMBER
CAMPAIGN	11-01-022
DATE	MODEL
JUNE, 2011	SONATA HYBRID (YF HEV)

SUBJECT NVLD INSPECTION/REPLACEMENT AND ECM UPDATE
(SERVICE CAMPAIGN TF9)

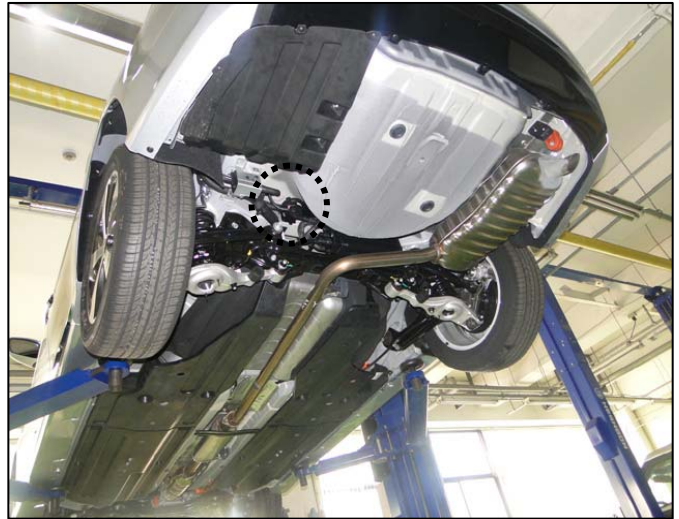
1. Turn off the ignition key and lift up the vehicle.
2. Locate the NVLD on the left side of the fuel tank.

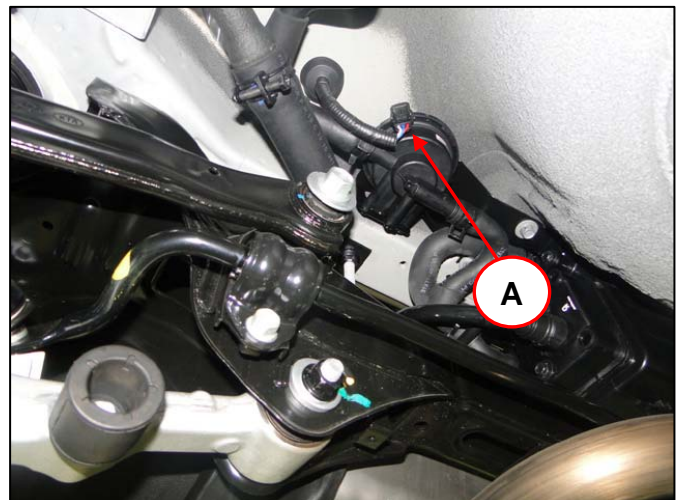
3. Disconnect the NVLD wiring connector (A).

When reconnecting the NVLD wiring connector, be sure to fully reconnect it until a clicking sound is heard.

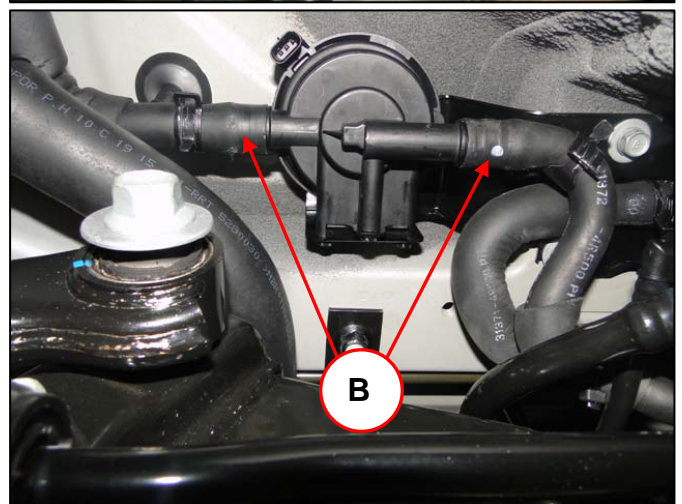
4. Disconnect the ventilation hoses (B).

When reinstalling the ventilation hoses, be careful not to twist them or airflow restriction may result.

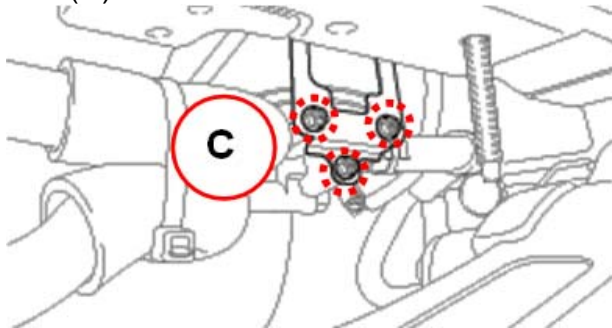
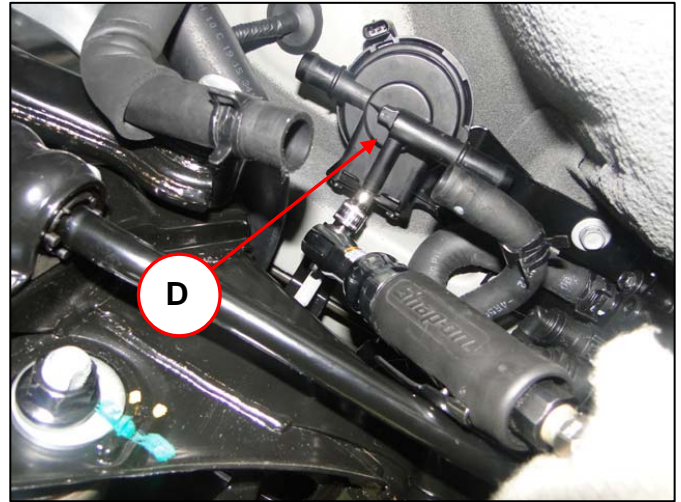
5. Remove the NVLD (D) by unfastening 3 bolts (C).
